LUBBER RUN AMPHITHEATER (LRA) SITE AND FACILITY ASSESSMENT

Conducted By LRA Community Supporters

March 27, 2011

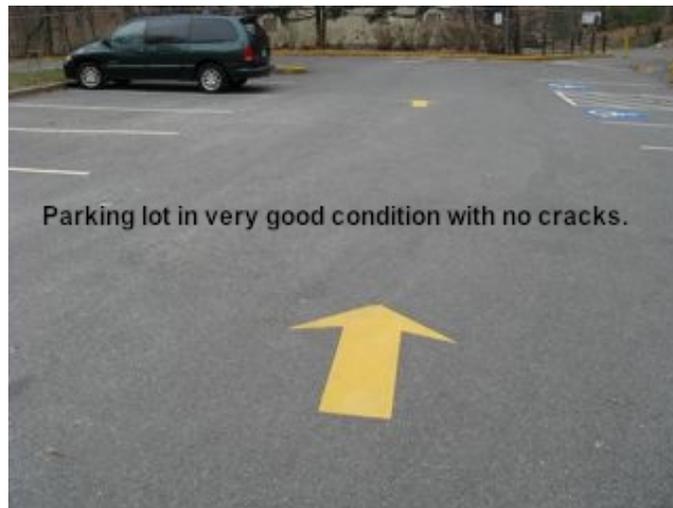
- a. All asphalt paving in the Parking Lot was in excellent condition, not deteriorated. No repair is required at this time. (photo 1.a)

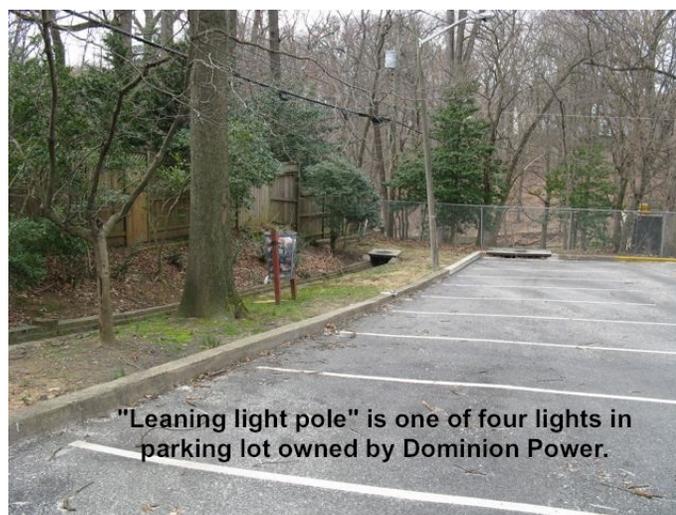
- b. Parking Lot lighting is provided by four DVP poles, three of which are leaning. (photo 1.b)

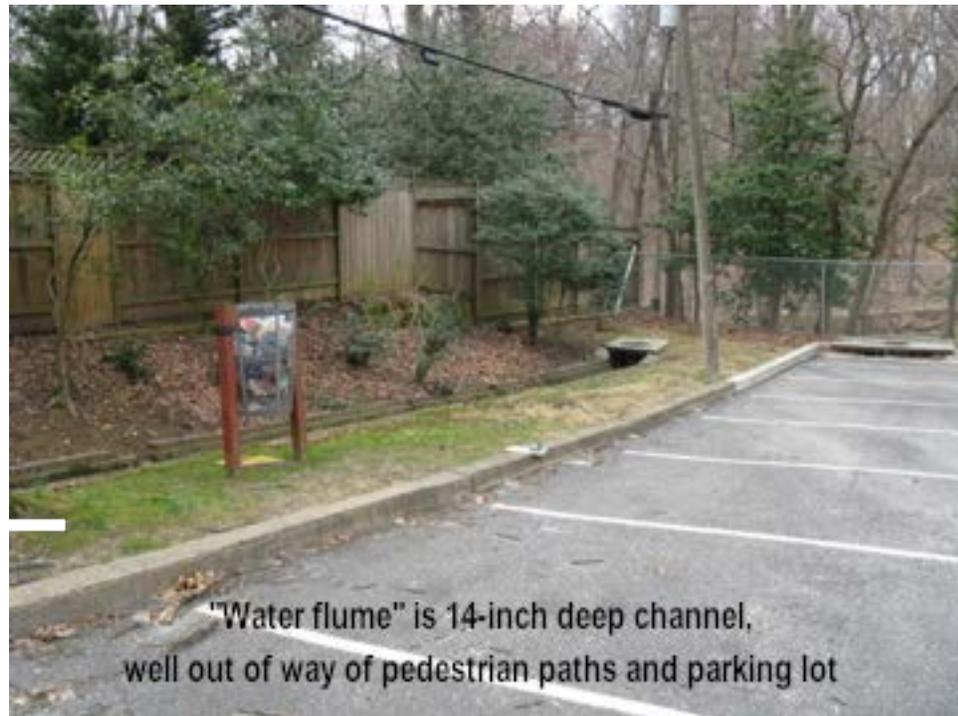
d. A shallow water run-off channel (14-16 inches deep) runs parallel to and approximately 9.5 feet from the curb line of the Parking Lot. (photo 1.c)

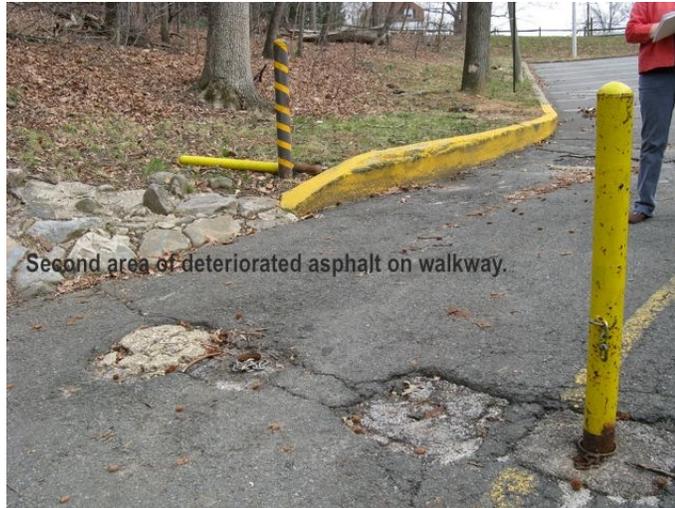
a. A narrow asphalt depression crosses the entry path. It reaches a depth of 1.5 inches in a section near the handrail and should be patched. Additional portions of the asphalt path are in poor condition and should be repaired. The open hole that seats a metal pole meant to prevent unauthorized vehicle access could be filled since the pole is often missing. (photo 2.a)

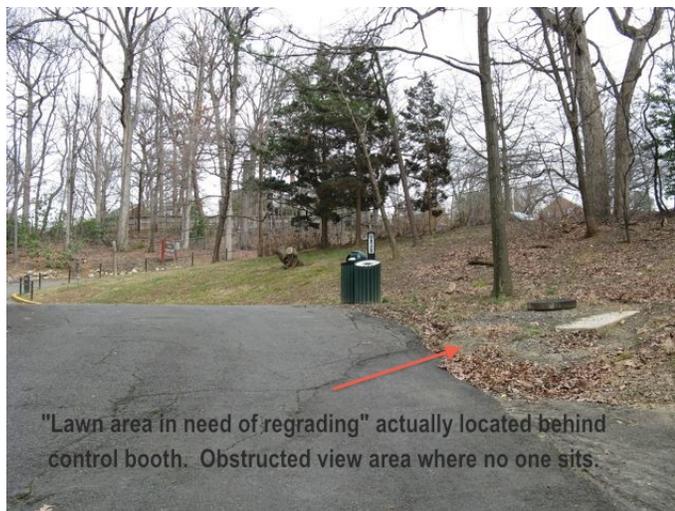
b. A grassy slope between the asphalt path and the main seating area rises toward the parking lot level. It currently provides adequate auxiliary seating and a play space for energetic children. There is smooth access to it and good grass coverage on it. No grading or reseeding is needed at this time. (At the far end of the area behind a control booth there is an obstructed view of the stage and fallen tree branches covering washed out terrain. Minor filling/level to path level is recommended.) A tree stump at the center of the grassy slope props up chairs and supports picnic coolers; no removal required. No additional terracing is required at this time. (photo 2.b)

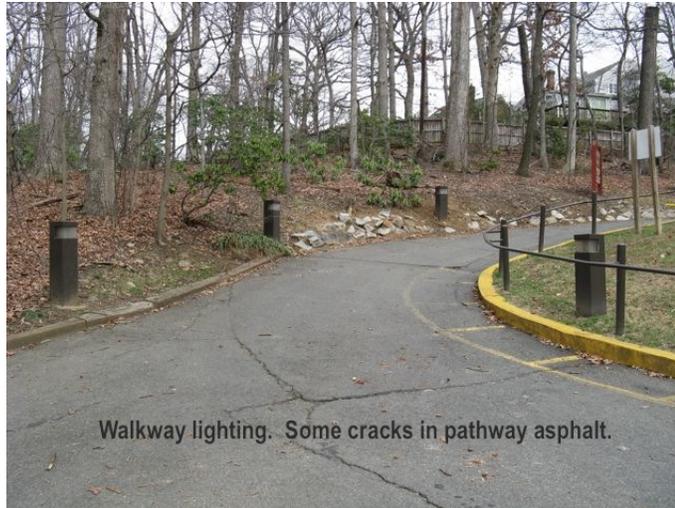
d. Bollard lights line the path. *Backup data needed* to determine sufficiency of existing lighting. (photo 2.c)

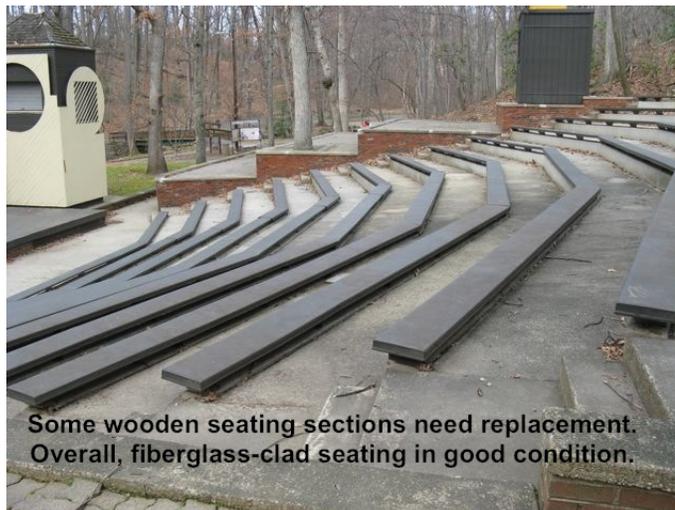
a. Seating for LRA consists of 13 rows of low, bench seating located on graduated tiers. The top and bottom rows are wood; there are several cracked boards that may need replacement. Some paint is needed on the top row. Six additional rows are entirely clad in a product that appears to be **molded fiberglass** rather than the described *sheet metal*. The remaining five rows have **molded fiberglass** cladding on both end sections and are unclad in the central section. All rows appear firm. Several **molded fiberglass** covers require new rivets. (photo 3.a)

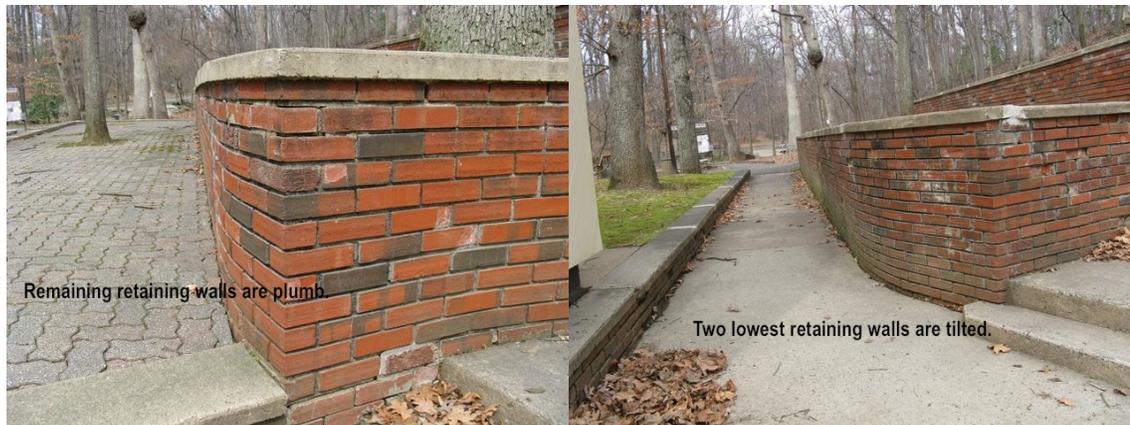
b. Retaining walls of red brick flank the seating area. The bottom right side wall tilts forward. The upper right side walls are plumb. Walls on the left side have more significant tilting on several levels. Many of the walls have serious cracking and should be repaired. (photo 3.b)

c. The walls are topped with **concrete** coping, rather than the described *stone*. A wash could be used to visually improve the look of unsightly existing repairs. Several sections require a new **concrete** cap.

d. Brick is spalling in many locations and should be repaired.

e. Pavers are uneven on several levels of the retaining walls, especially on the left side.

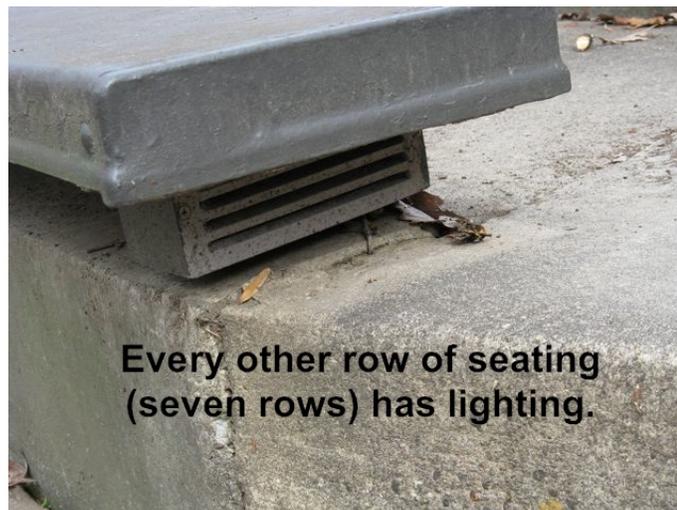
f. Foot level lighting units are located on every other seat row at both ends. *Backup data needed* to determine sufficiency of existing lighting. (photo 3.c)

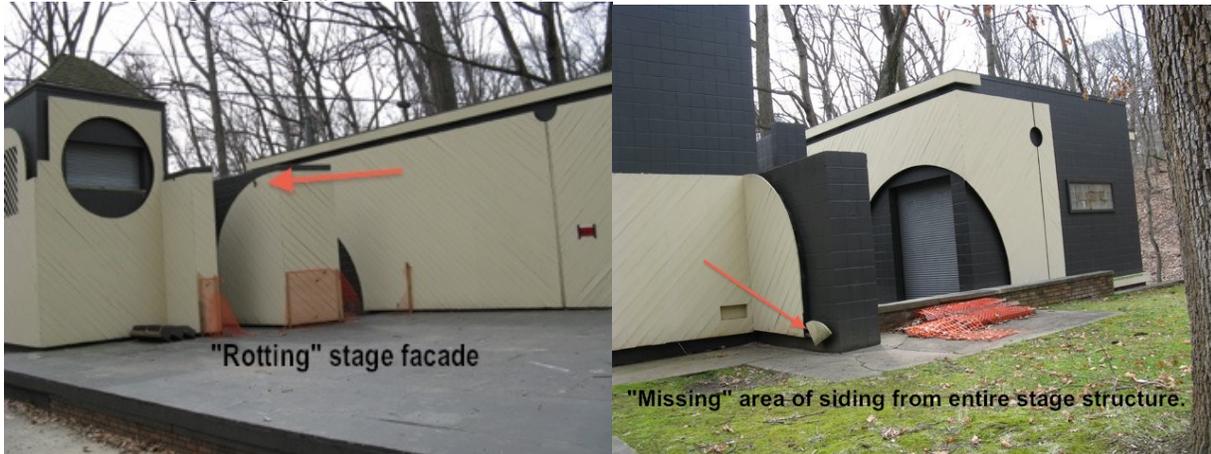
d. The stage house is a solid block building with well-maintained paint. Parts are sheathed with diagonally placed 1x6 boards with are used decoratively and to screen the light booths. Fewer than 15 boards (undetermined length) are necessary to address rotting boards/missing siding. (photo 4.a & 4.b)

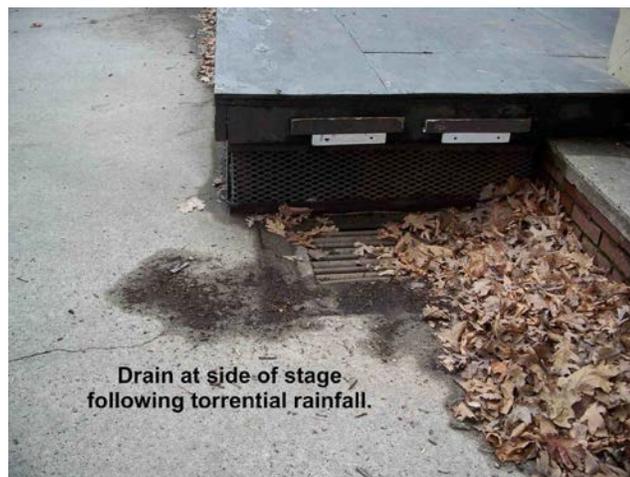
g. There is a grated drain at the each corner of the stage. The drain grates are blocked by leaves. *Backup data needed* to determine performance with regard to water drainage in front of the stage. (photo 4.c)

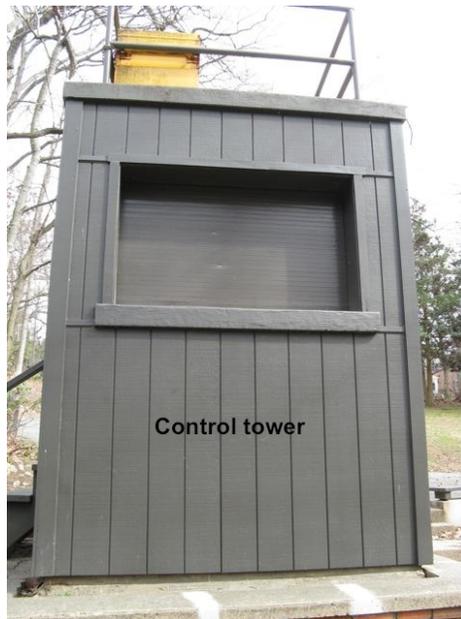
a. The existing booths are sided with grooved plywood panels and are well maintained and neatly painted to match the Stage House. A piece of 1"x4" -9' corner trim has severely rotted and needs replacement on the left side booth. Modest mold deposits at top of both booths can be pressure-washed or bleach-wiped. (photo 6.a)

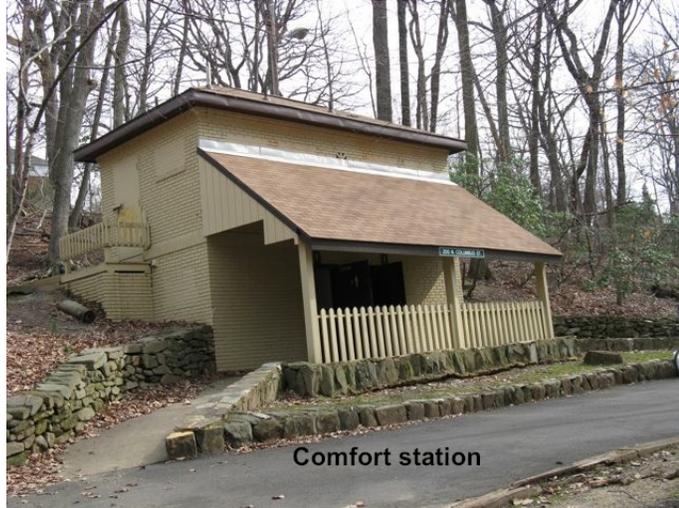
a. The Comfort Station building exterior is well maintained, with recent roofing and paint. (photo 7.a)

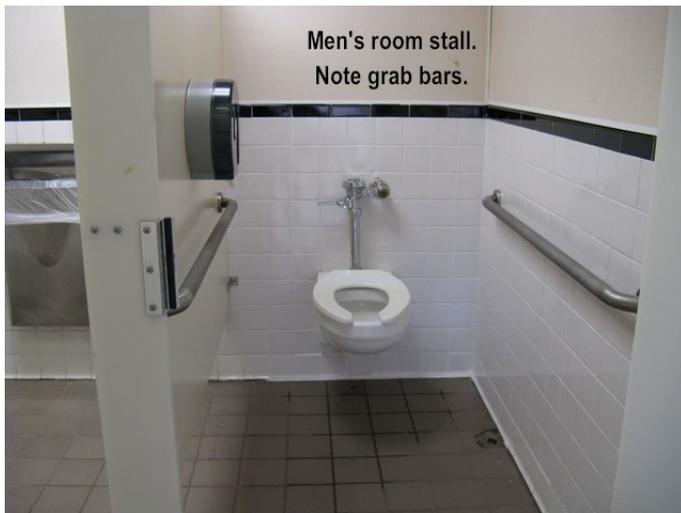
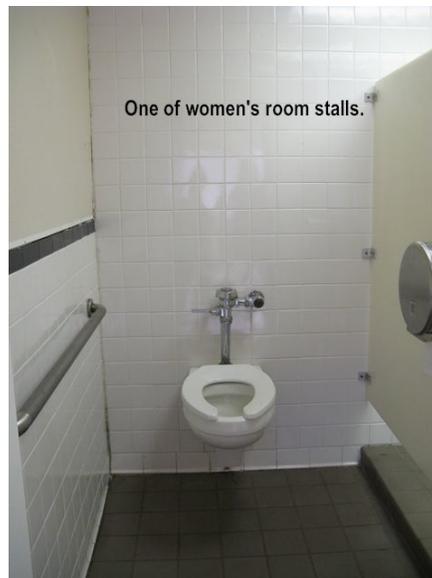
b. The PNA report indicates possible corrective ADA actions may be needed. An examination of the restrooms showed that both the men's and women's rooms had one large sized stall 48 inches wide with grab bars. (photo 7.b & 7.c)
